Manhole Inspection Summary

Manhole # S13AA_027MH

Insp Date: **7/28/08 11:28 AM**

Location Address: **REAR 2730 MOSHER ST**

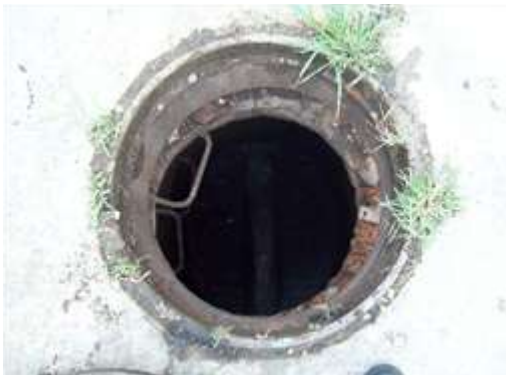
Top View

OFFSET

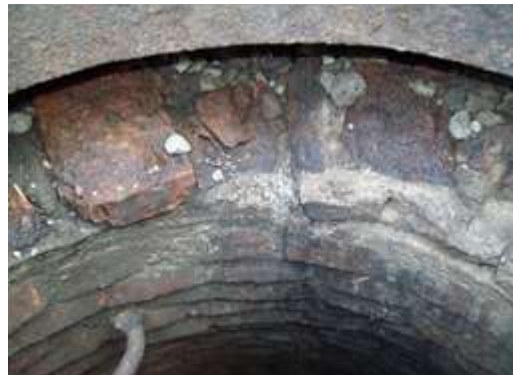
Defect 2

Condition: ☐ Sound ☒ **Cracked** ☐ Root Intrusion ☒ **Loose Brick** ☐ Deteriorated

CRACKED CHIMNEY AND LOOSE BRICKS.

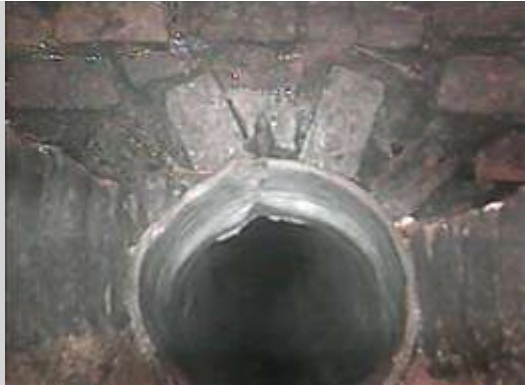
12 O'Clock Outflow

8 in. Circular Gravity Sewer
Pipe Out @ 12 O'Clock

Pipe Height: (in.) Direct
Pipe Material: **Clay** ☐ Pipe Lined
Invert Depth: **7.86** (ft.) Flow Characteristics: **Slow**
Deposits: ☐ None ☐ Mud ☐ Sludge ☒ **Debris** ☐ Grease
Silt Depth: **0** (in.) Deposits Extent: **Light**
Infiltration: **None** Pipe Seal Cond: **Sound**

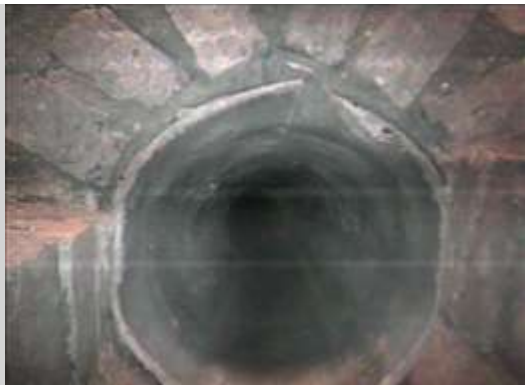
6 O'Clock Inflow

8 in. Circular Gravity Sewer
Pipe In @ 6 O'Clock

Pipe Height: (in.) Direct
Pipe Material: **Clay** ☐ Pipe Lined
Invert Depth: **7.41** (ft.) Flow Characteristics: **Slow**
Deposits: ☒ **None** ☐ Mud ☐ Sludge ☐ Debris ☐ Grease
Silt Depth: (in.) Deposits Extent:
Infiltration: **None** Pipe Seal Cond: **Cracked**
